Effect of Vibration on Electric-Submersible-Pump Failures

Marcus O. Durham, SPE, THEWAY Corp., and James H. Williams, SPE, and Dwight J. Goldman,* SPE, Arco Oil & Gas Co.

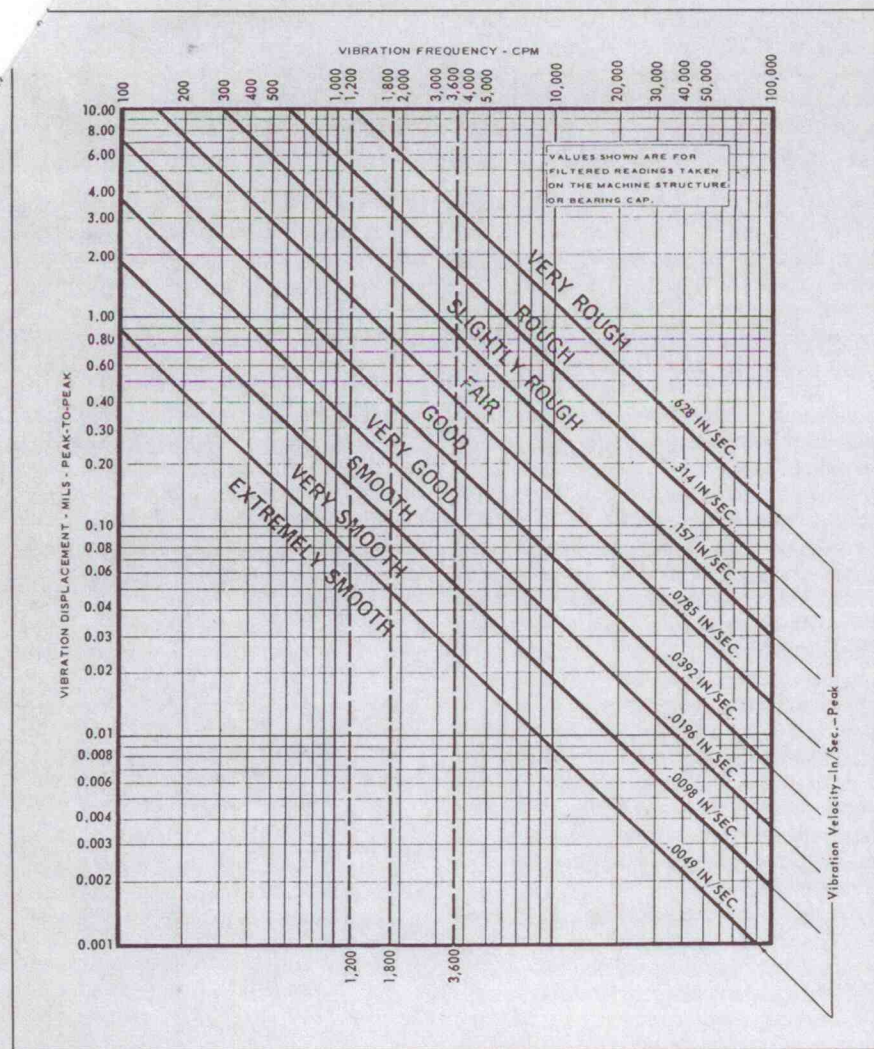
Fig. 2—General machinery vibration severity chart per IRD Mechanical Analysis.⁵

A guide accepted by the electric motor industry for vibrational evaluation is shown in Fig. 2. Because a conventional motor was used for the horizontal application, this guide is appropriate. Similar results would have been achieved with other standards.⁶

Fig. 2 correlates the effects of vibrational displacements at various machine operating speeds. For a 3,600-rev/min machine, such as an ESP, this chart indicates that good performance exists with displacement ampli-

tudes less than 0.4 mil [0.1 μm]. Rough operation begins above 0.8 mil [0.2 μm], and impending failure above 3 mils [0.76 μm].
